**CALIFORNIA REGIONAL WATER QUALITY CONTROL BOARD - SAN DIEGO REGION
WATERSHED MANAGEMENT PROGRAM**

FACILITY INSPECTION REPORT

INSPECTION DATE: **January 4, 2005**

FACILITY: Morro Hills Villages
C,D,E,G

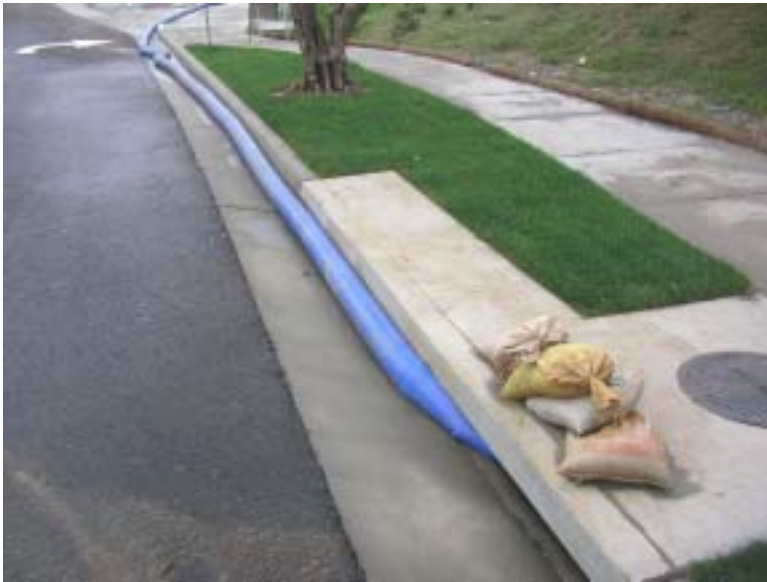
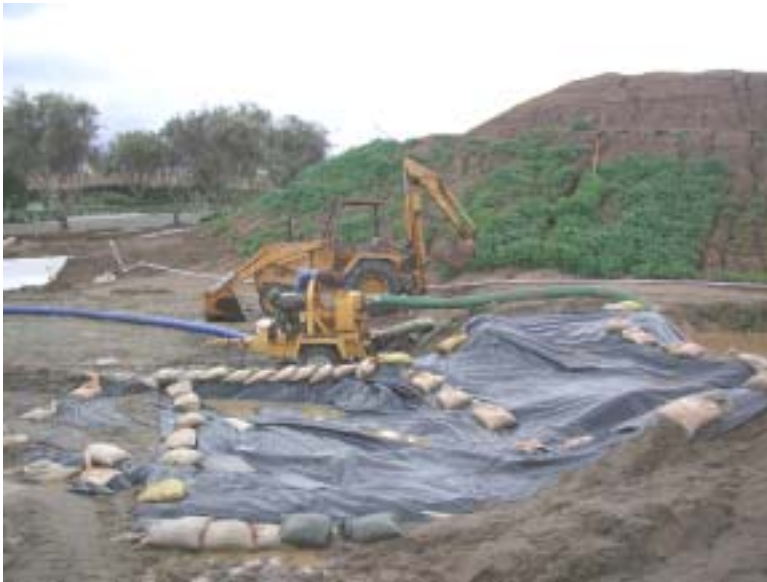
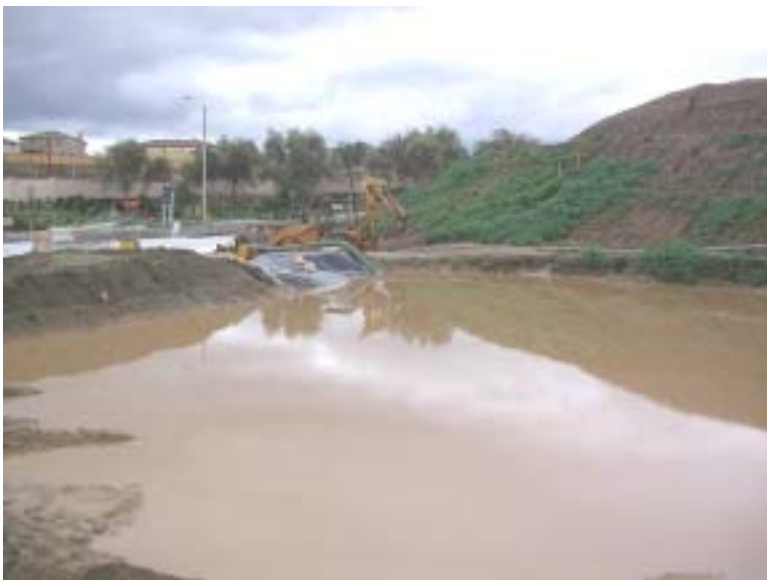
- While driving onto the site on Douglas Drive a flexible blue pipe aprox. 8 inches in diameter was observed going into the City of Oceanside MS4 catch basin, and the sound of a pump was noted. Upon further investigation it was established that the pump was discharging sediment laden water without any form of filtration from an impoundment located in Village G of the Fieldstone construction site directly into the City's MS4. (see attached inspection photos)

Illicit discharge of sediment laden storm water without any form of filtration directly into the City of Oceanside MS4, witnessed by Regional Board inspector. Pump was running for approx. 30 minutes after inspector was on site. Previous storm had overwhelmed sediment containment structures on site, and superintendent stated they were relieving pressure before next set of storms hit.

- City of Oceanside staff will fax over past enforcement actions/inspection reports.
- Developer needs to immediately start implementing an effective combination of erosion and sediment control BMPs.
- A follow-up inspection is warranted to assess level of BMP implementation on a site wide basis.
- The deliberate nature of the discharge to the City of Oceanside MS4 after earlier meeting with City Stormwater staff, and the absolute lack of adequate BMPs onsite during the rainy season warrants this case being forwarded to the Regional Board Enforcement unit for further enforcement action.

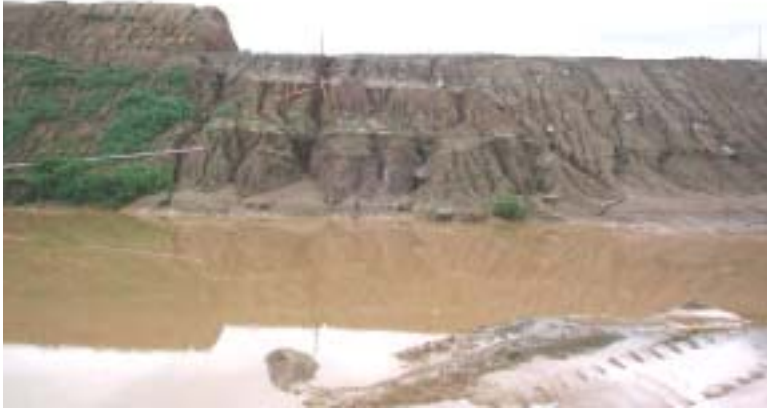
- The whole site was not inspected, but the areas I could see were lacking any erosion control BMPs on disturbed areas. Gully and rill erosion were widespread. Sediment control BMPs, were overwhelmed.

Site had no apparent erosion control implemented to stabilize interior slopes. Gully and rill erosion was wide spread. These two slopes were typical of all slopes on site.

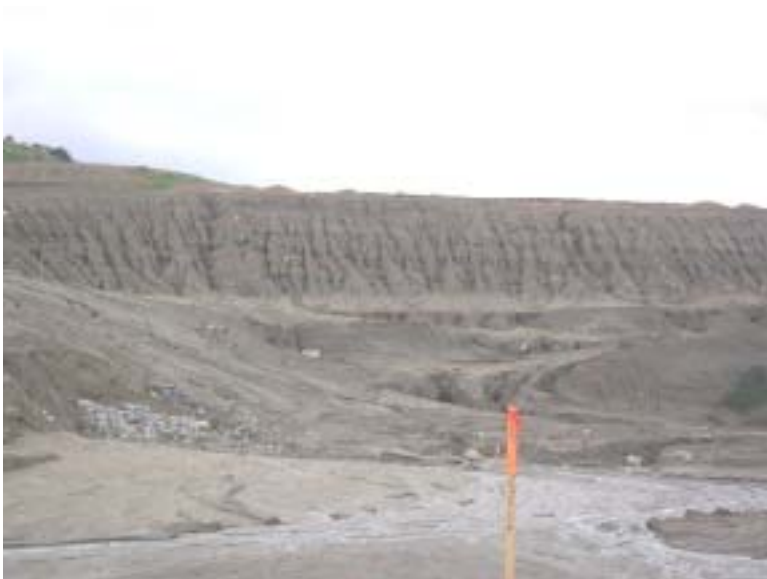
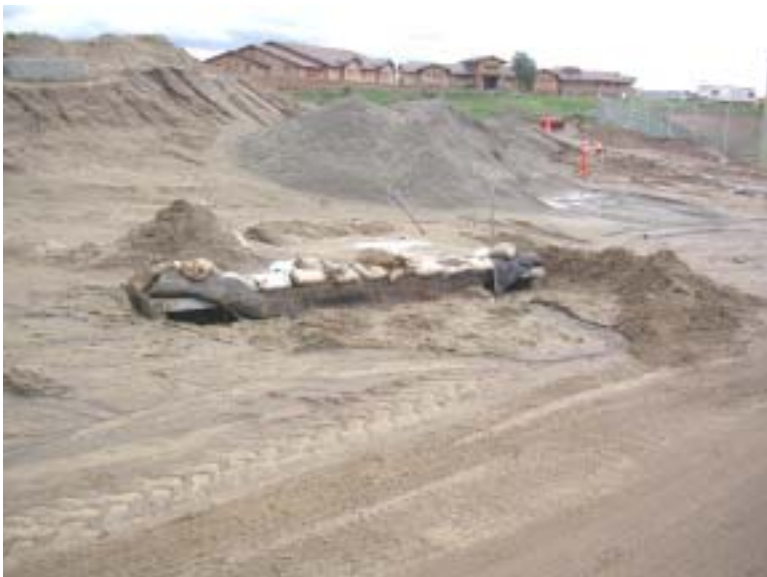
Dirt road south of illicit discharge point did not have adequate BMPs implemented to prevent the discharge of sediment into storm drain. Filter fabric had been peeled back at both edges, and berm was constructed to funnel sediment laden water unobstructed into catch basin.
